**NOTICE OF VIOLATION # PC 1307-099**

**Site Inspection Report**

**Tracking ID: PC 1307-099**

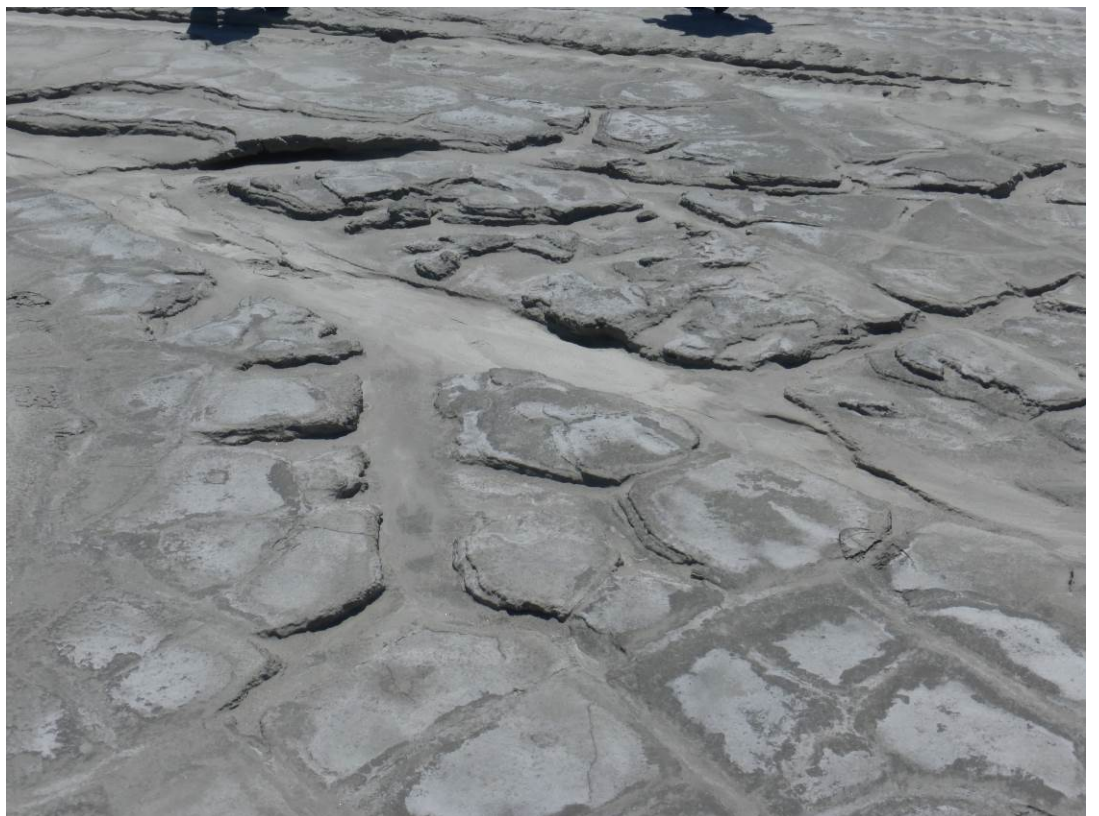
**Photo No. 10**

In general, we found the north dam surface to contain cracks and channels of varying depths (Attachment 1, Photos 10 – 13). The cracks, and especially the channels, contained loose, dry particulate. Mr. Gonzales indicated that cracking may be caused by light rain followed by hot, dry weather. The loose material in the channels appeared sandy and was somewhat aligned along southeast edges of channels. The loose channel material was not as fine as particulate created by disturbing the surface and did not appear highly susceptible to becoming windblown. Mr.

Gonzales indicated that channeling is caused by the deposition and flow of tailings slurry. Three All-Track vehicles were applying magnesium chloride in the southeast area of the north dam during the inspection. We did not observe any excessive dust while inspecting the north dam. A wind measurement while on the dam showed winds from the southwest at a maximum speed of 10.2 mph and an average speed of 7.5 mph.

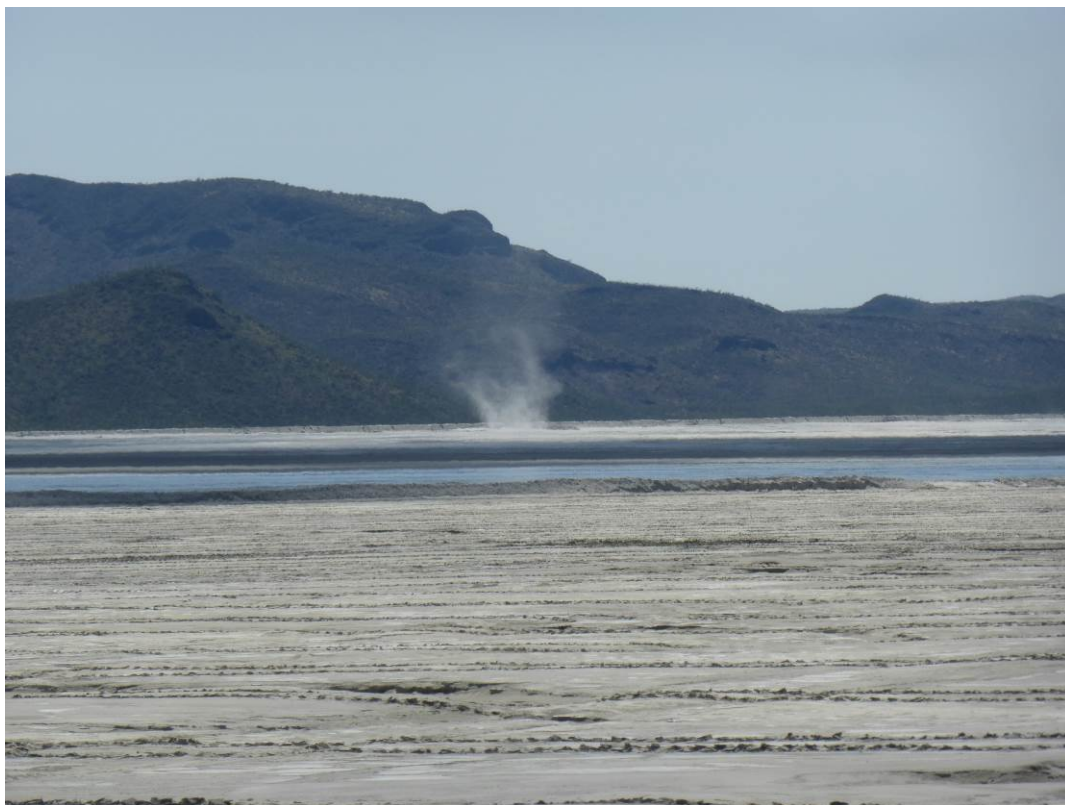
**Photo No. 15**

While on the north dam, we saw dust devils originate along the berm of the southwest portion of the south dam (Attachment 1, Photo 15). The dust devils dissipated soon after leaving the edge of the dam as they traveled northeast onto the south dam surface. We drove to south dam area and saw loose material in cracks on the berm, the apparent source of dust for the dust devils. The south dam surface appeared stable and Mr. Gonzalez called the water truck to increase stabilization of the berm areas. The dust devils were the only airborne fugitive particulate matter observed during the inspection.

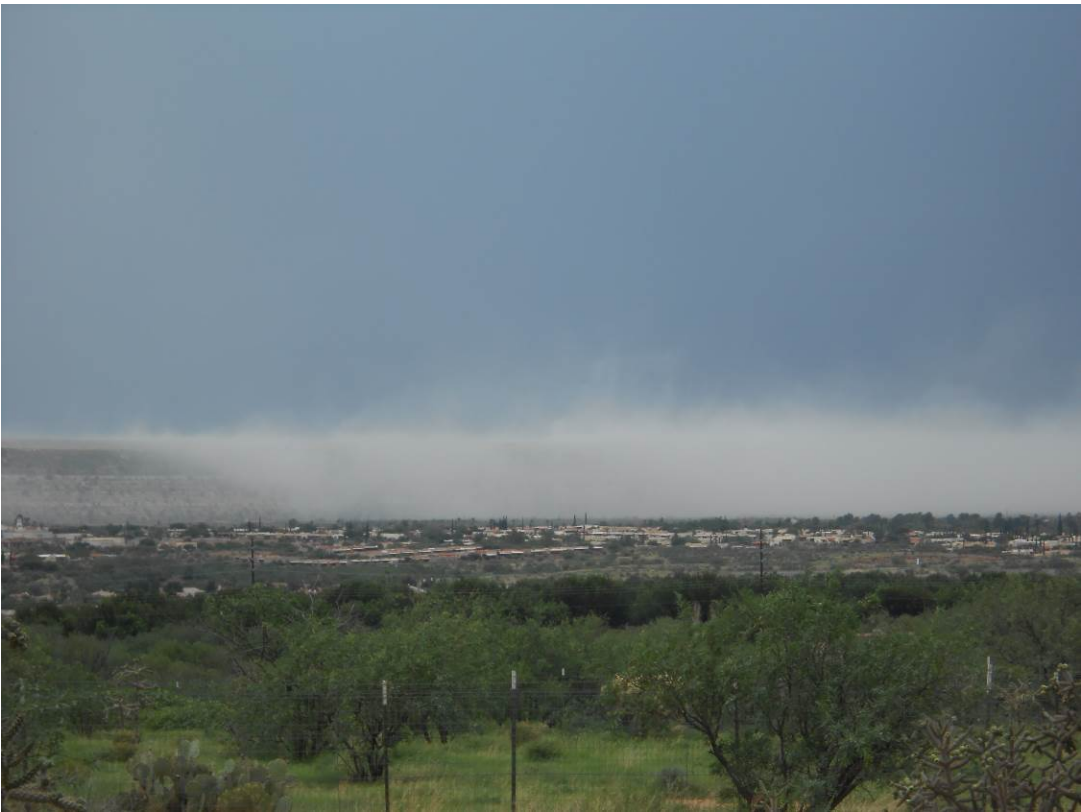
| <b>Photo No. 3</b> | |

Fugitive dust emissions from the FMSI tailings impoundment were photographed by a PDEQ inspector from 3:21 pm to 3:41 pm on July 27, 2013. A complaint received by PDEQ reported a 3:27 pm fugitive dust emission from tailings. Photographs, PDEQ inspector observations, and on-site inspection reveal the emissions originated from the north section of the north dam. The inspector observed white dust clouds originating from the north dam travel eastward over the side of the dam. The dust moved southeast, crossing I-19. The inspector observed fine, white tailings dust of sufficient density to obscure local vegetation on property over 2.25 miles from the closest FMSI property boundary. The inspector observed the dust continue to travel toward the Santa Rita Mountains.

Pursuant to Permit Condition Part B, Section II, E and PCC 17.16.050, FMSI allowed diffusion of tailings-generated visible emissions beyond the property boundary. Though wind speeds recorded at FMSI were greater than 25 mph on July 27, 2013, the control measures taken by FMSI to prevent the diffusion of visible emissions were not commensurate with the amount of tailings impoundment surface area susceptible to becoming airborne.

- Employ control measures to prevent diffusion of tailings-generated visible emissions beyond the property boundary.
