**NOTICE OF VIOLATION # PC 1307-099**

**Site Inspection Report**

**Tracking ID: PC 1307-099**

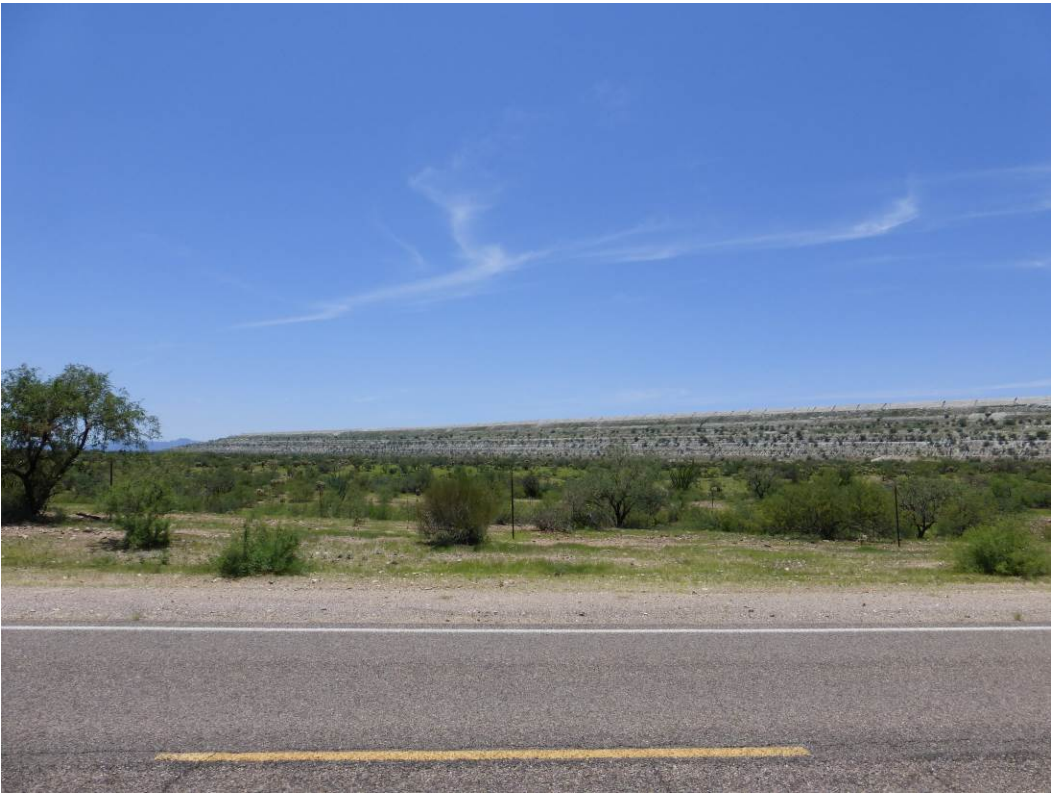
| <b>Photo No. 1</b> | | | |

We conducted off-site surveillance and an on-site inspection of the FMSI tailings impoundment on the afternoon of July 29, 2013. We observed the tailings impoundment from Continental Road, southeast of the water tank and observed no fugitive dust (Attachment 1, Photo 1). Winds blew from the south with a maximum speed of 7.1 mph and an average speed of 4.7 mph. We observed the tailings impoundment from the intersection of Duval Road and Mission Road and observed no fugitive dust (Attachment 1, Photo 2). Winds blew from the south at a maximum speed of 2.5 mph and an average speed of 0.8 mph.

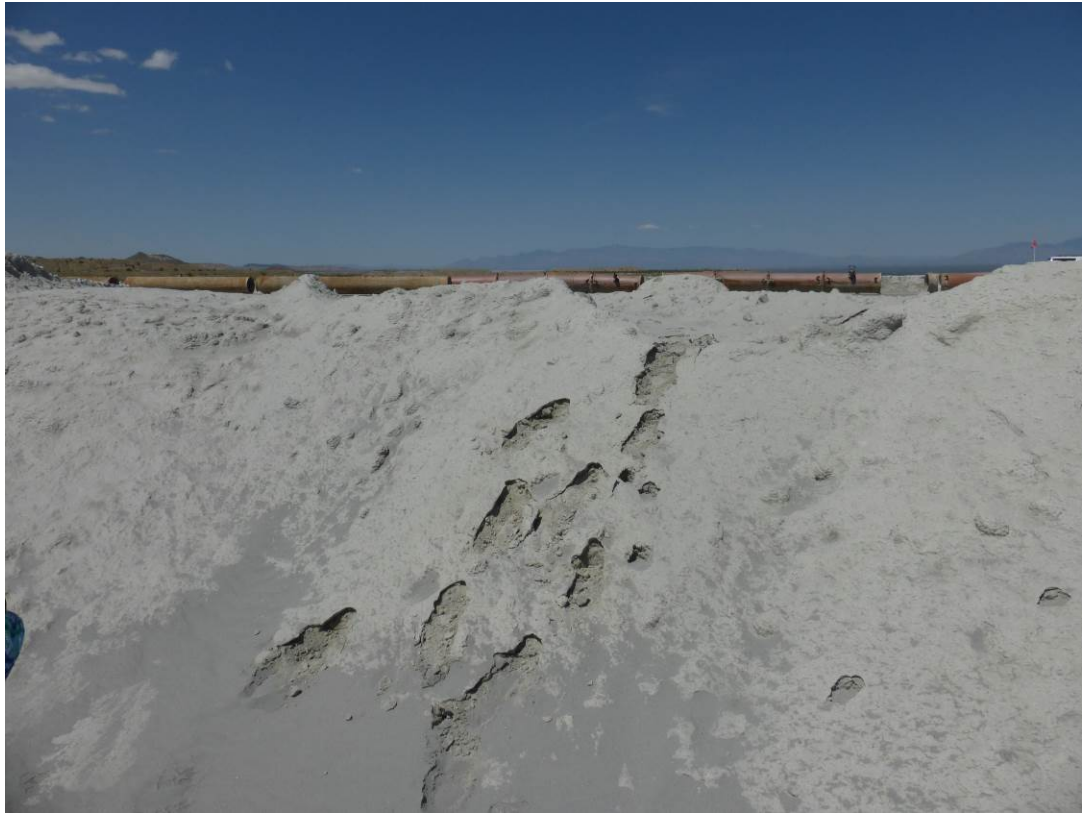
**Photo No. 5**

We entered FMSI, met with Ms. Kali Hoyak, Environmental Engineer II, and Eric Werner, Environmental Engineer I, and conducted inspection rights protocol (Attachment 2). We reviewed the content of the complaints with Ms. Hoyak and Mr. Werner and showed them photos of the fugitive particulate matter event on July 27, 2013 (Attachment 3). Ms. Hoyak stated that she was not aware of any July 27, 2013 fugitive emissions until PDEQ contacted her on July 29, 2013. We drove to the north side of the tailings impoundment and met with Mr. Procopio Gonzales, FMSI Senior Tailings Supervisor. We conducted inspection rights protocol with Mr. Gonzales (Attachment 2) and began discussions about recent and current activity on the tailings impoundment. We learned that FMSI is currently depositing tailings slurry on the southern half (south dam) of the tailings impoundment and that the north side (north dam) is undergoing road construction and pipeline lifts, to raise the dam walls which contain the tailings. We learned that the pipeline lift was underway on the north edge of the impoundment dam. This pipeline lift follows the near-completion of a new road around the tailings impoundment. Ms. Hoyak and Mr. Gonzales indicated that the road along the north edge of the impoundment dam was complete except for capping with native soil. They stated that magnesium chloride had been applied to the road at least twice since its construction. The road appeared stable (Attachment 1, Photo 3) and we observed traffic traveling at or below the speed limit of 25 mph generating little to no dust. Between the road and the tailings lay berms and stockpiles of soil from road construction. The road was bordered with piles and pushed berms of tailings soil material. We observed water trucks spraying the soil (Attachment 1, Photo 4) and found the piles to be well-crusted and stable (Attachment 1, Photo 5). Mr. Gonzales indicated the piles are sprayed by a water truck approximately every 2 hours.
